# Sample Flat

Musterstraße 12, Berlin 10115, Germany

INSPECTION

Move-in · Sep 29, 2026

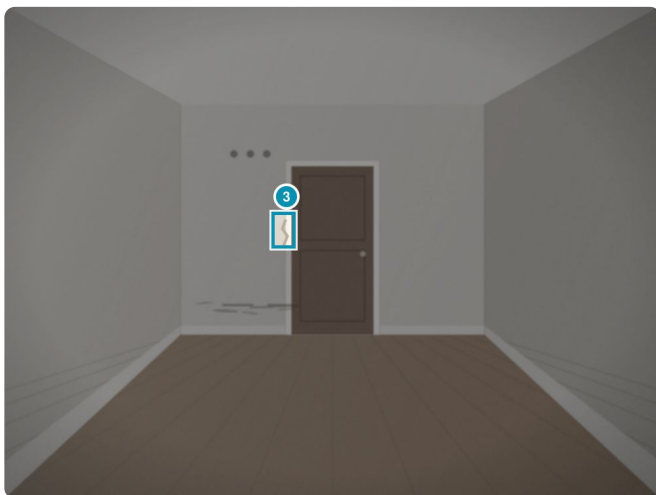
Photo 1 — Entrance door and coat hooks

### 3 Vertical mark beside door frame Minor

A short, narrow vertical mark or scratch is visible on the wall paint next to the door architrave. It appears cosmetic and limited to the paint surface.

Wall to the left of the entrance door frame, at approximately handle height · walls · See photo 1

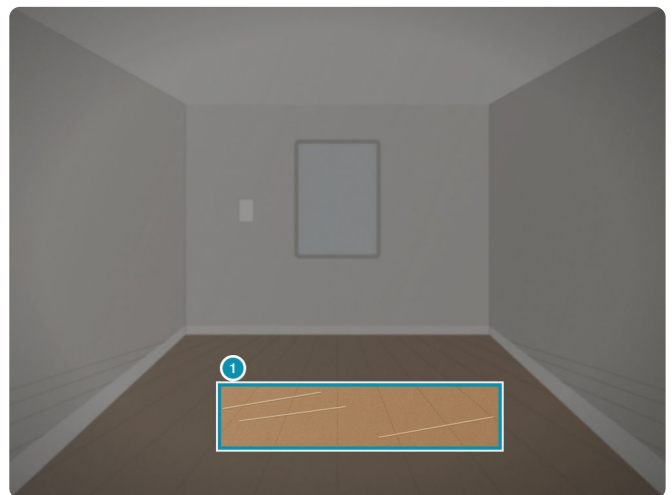
Photo 2 — Mirror wall and floor

### 1 Surface scratches on floor Minor

Several thin, light-coloured linear scratches run across the wood-effect floor boards. They read as surface scuffing rather than gouges or missing planks.

Centre of the floor in the foreground, in front of the mirror wall · floor · See photo 2

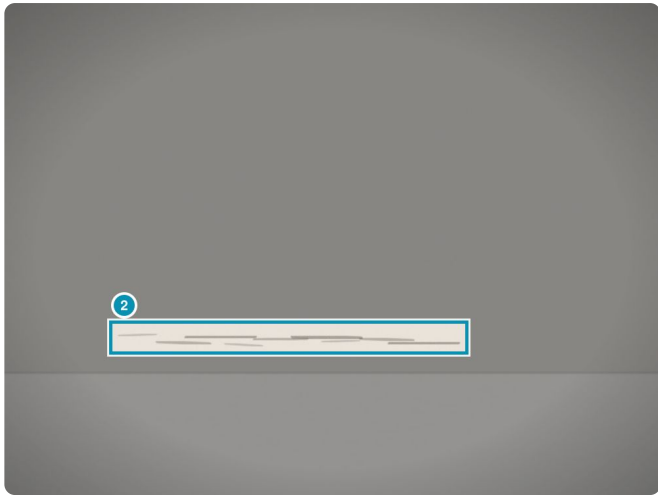
Photo 3 — Wall above the skirting board, close-up

### 2 Scuff and scratch marks on wall above skirting Minor

A horizontal band of grey scuff and scratch marks runs along the wall just above the skirting board. The marks are surface-level on the paint with no visible dents or exposed substrate.

Wall immediately above the skirting board, on the entrance-door wall (also visible in photo 1) · walls · See photo 3

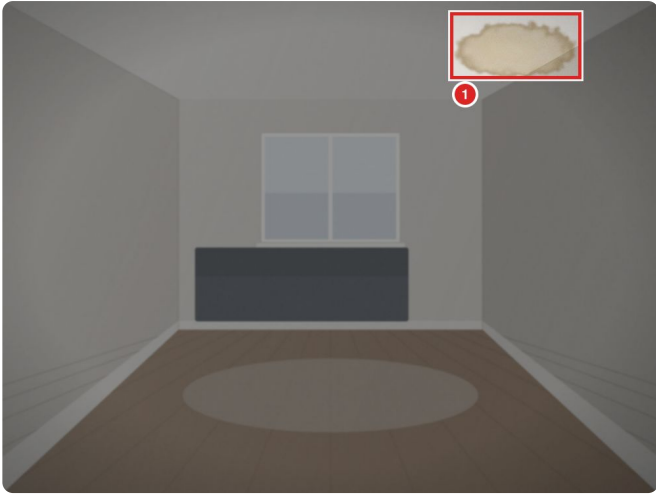
Photo 4 — Window wall and sofa

### 1 Brown stain on ceiling near right wall Major

An irregular tan/brown discoloured patch roughly 0.5 m across is visible on the ceiling with darker concentric edging typical of a water mark. No cracking, sagging or dripping is visible from this distance.

Ceiling, upper right of the photo, close to the junction with the right-hand wall · ceiling · See photo 4

Follow-up photo: Take a straight-on close-up of the ceiling stain seen in the upper right of Photo 1, ideally with a torch held at a low angle to show texture and any sagging.

Follow-up photo: Take a close-up of the window frame, sill and surrounding wall in Photo 1 to check for moisture or damage below the stained ceiling area.

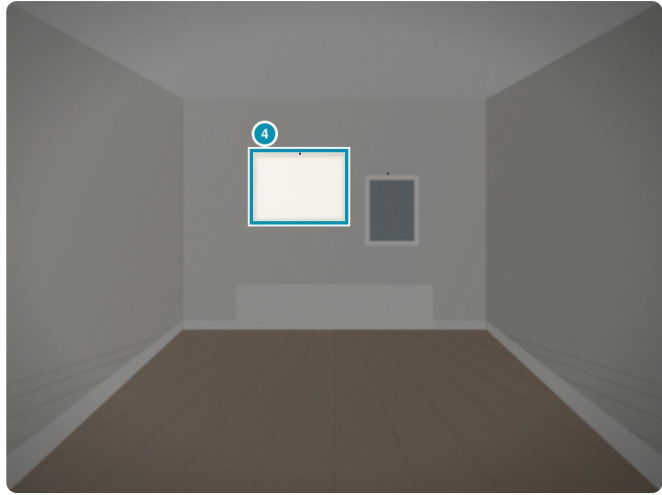
Photo 5 — Sideboard wall

### 4 Pale rectangular patch on wall Minor

A lighter rectangular area of wall is visible below an exposed hook, consistent with an unfaded or repainted patch where a frame previously hung. Strong local lighting in the photo makes it uncertain whether this is discolouration or a reflection.

Upper middle of the far wall, left of the hanging picture, beneath a small wall hook · walls · See photo 5

Follow-up photo: Re-shoot the pale rectangular area on the wall in Photo 2 straight on and without flash or strong directional light, to confirm whether it is a discoloured/patched area or a lighting artefact.

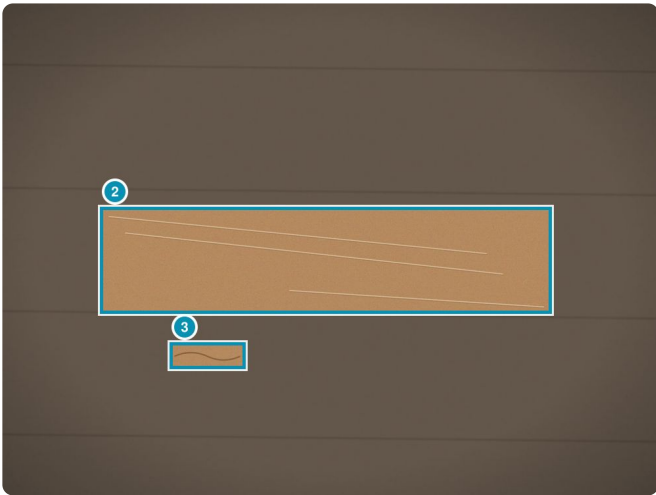
Photo 6 — Floorboards near the sofa, close-up

### 2 Surface scratches on floorboards Minor

Three long, fine light-coloured scratches run diagonally across two floorboards. They appear to be surface-level marks in the finish rather than gouges through the board.

Centre of the close-up floor photo, described as near the sofa · floor · See photo 6

### 3 Short curved mark on floorboard Minor

A short wavy dark line is visible on the board surface; it may be a scuff or a shallow indentation in the finish.

Lower left of the close-up floor photo, below the scratch cluster · floor · See photo 6

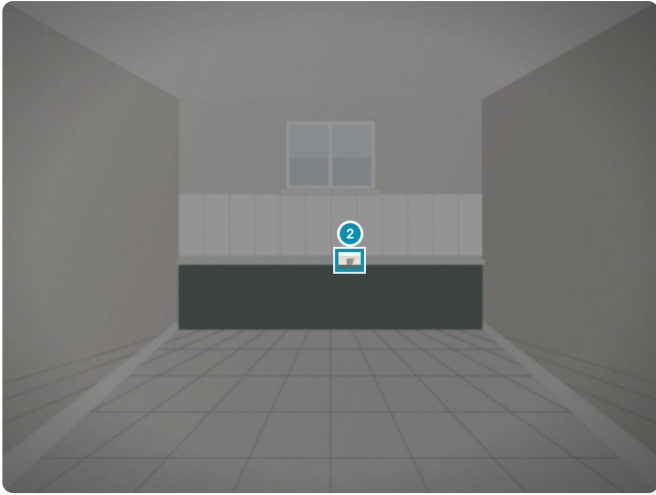
Photo 7 — Worktop and splashback

### 2 Small mark on worktop front edge Minor

A small dark grey mark is visible on the underside/front edge of the worktop below the window. At this distance it cannot be determined whether it is a chip, a fitting or a surface stain.

Front edge of the worktop directly below the window, centre of the photo · cabinetry · See photo 7

Follow-up photo: Take a straight-on close-up of the worktop front edge beneath the window (the small mark visible at the centre of Photo 1) to confirm whether it is a chip, fixing or surface stain.

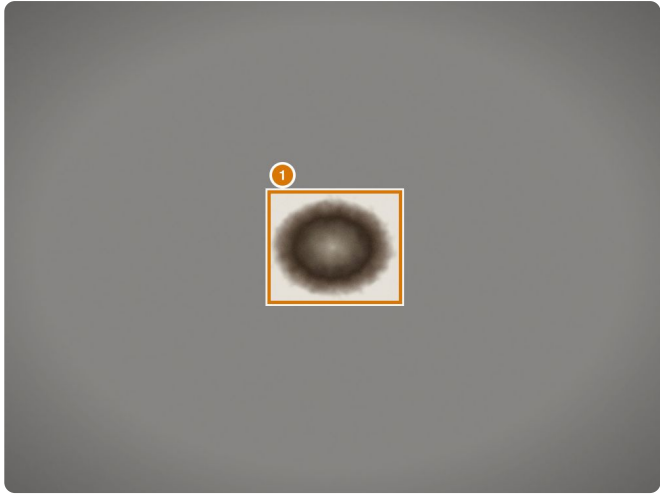
Photo 8 — Worktop surface, close-up

### 1 Dark circular stain on worktop surface Moderate

A roughly circular dark brown mark approximately the size of a ring/cup base, with a diffuse feathered edge and a lighter centre, sits on the otherwise pale, uniform surface. The photo does not resolve whether the surface is scorched, etched or only discoloured.

Centre of the close-up worktop surface · other · See photo 8

Follow-up photo: Retake Photo 2 from slightly further back with even lighting and the full worktop section in frame, including a scale reference (e.g. a ruler or coin), so the size and nature of the dark ring mark can be judged.

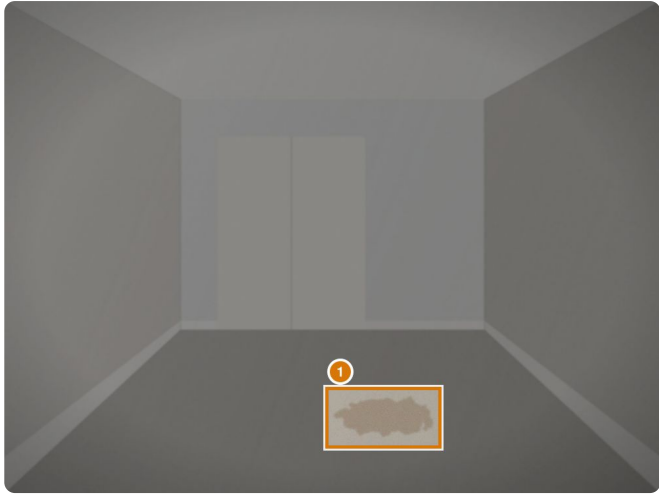
Photo 11 — Wardrobe and carpet

### 1 Discoloured patch on floor covering Moderate

An irregular brown patch of discolouration is visible on the light-coloured floor covering. Its edges are diffuse and darker than the surrounding surface, consistent with a stain rather than a shadow.

Centre of the floor, roughly 1–1.5 m in front of the wardrobe doors · floor · See photo 11

Follow-up photo: Take a close-up of the stain in Photo 2 from about 1 m, straight on and with even lighting, plus a wider shot showing its distance from the wardrobe.

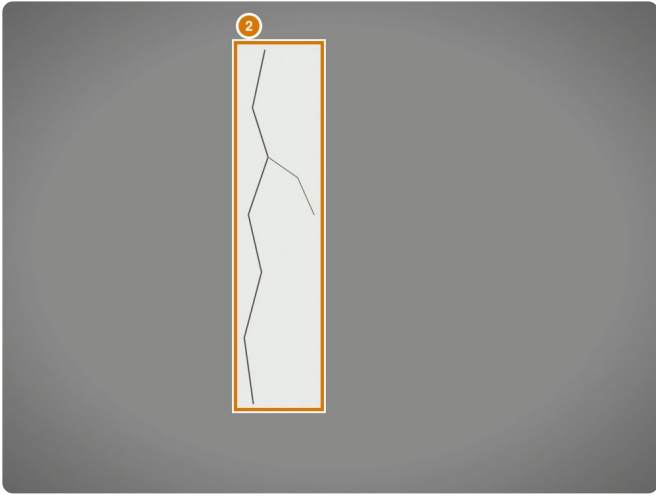
Photo 12 — Wall left of the window, close-up

### 2 Branching crack in wall paint/plaster Moderate

A thin, jagged vertical crack with a secondary branch runs through the wall finish. It is visible as a continuous dark line in the close-up and as the same line descending from the ceiling to the window head in Photo 1.

Wall above and to the left of the window, running down from the ceiling line toward the window head (shown in context in Photo 1) · walls · See photo 12

Follow-up photo: Retake the crack from Photo 3 with a wider framing that includes the ceiling line and window edge, and add a scale reference (e.g. tape measure) alongside it.

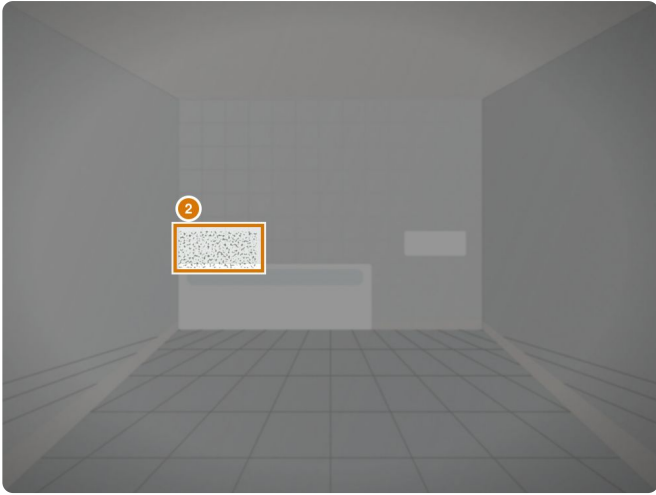
Photo 13 — Bath and tiled wall

### 2 Dark speckled discolouration on tiled wall above bath Moderate

A rectangular patch of the wall tiling shows dense dark speckling contrasting with the surrounding clean white tile, consistent with mildew or staining in a splash zone. The affected area spans roughly two tile courses immediately above the bath edge.

Tiled wall at the head end of the bath, left side of the rear wall just above the tub rim · mold-moisture · See photo 13

Follow-up photo: Provide a close-up of the speckled/discoloured area on the tiled wall above the bath (seen at left in photo 1), including the grout lines and the bath-to-wall sealant joint.

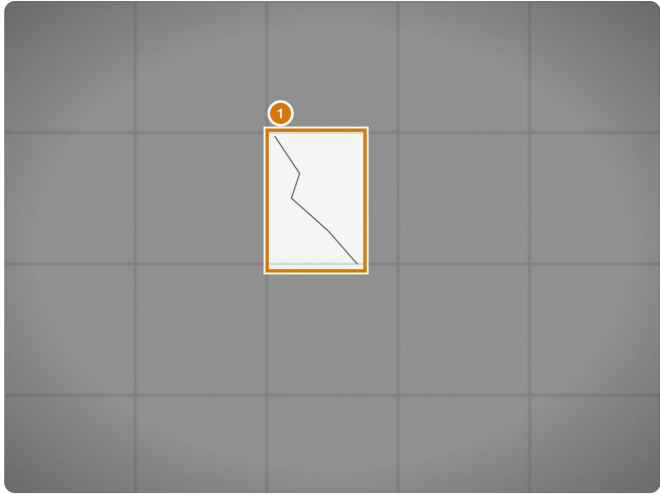
Photo 14 — Wall tiles, close-up

### 1 Cracked wall tile Moderate

A distinct dark, jagged crack runs diagonally across one wall tile from its upper edge to its lower edge. The crack is confined to the single tile with no visible displacement of adjacent tiles.

Centre of the tiled wall, within a single tile in the close-up view · walls · See photo 14

Follow-up photo: Take a straight-on close-up of the cracked tile (photo 2) with a scale reference and indicate its position on the wall relative to the bath.

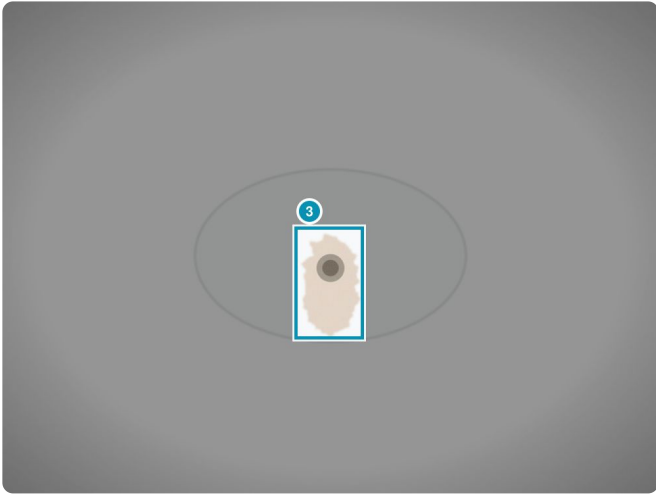
Photo 15 — Washbasin drain, close-up

### 3 Brown staining around washbasin drain Minor

A tan/brown irregular stain surrounds the drain fitting and extends down the base of the basin bowl. No cracking or chipping of the basin surface is visible in this view.

Basin bowl immediately surrounding and below the drain outlet · plumbing · See photo 15

Follow-up photo: Retake the basin close-up (as in photo 3) from slightly further back with even lighting, showing the whole bowl, tap, overflow and the countertop around it.

Follow-up photo: Photograph the under-sink plumbing and trap to check for leaks or moisture below the stained drain.
