# Sample Flat

Musterstraße 12, Berlin 10115, Germany

INSPECTION

Move-in · Sep 29, 2026

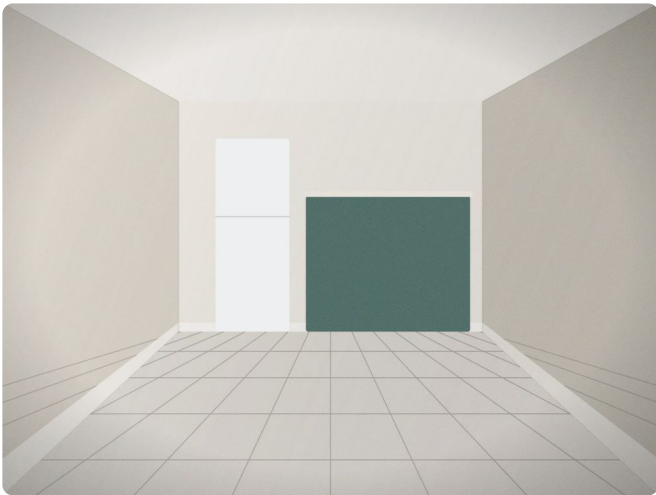
Photo 8 — Worktop surface, close-up

### 1 Dark circular stain on worktop surface Moderate

Centre of the close-up worktop surface · other · See photo 8

A small dark grey mark is visible on the underside/front edge of the worktop below the window. At this distance it cannot be determined whether it is a chip, a fitting or a surface stain.

Follow-up photo: Take a straight-on close-up of the worktop front edge beneath the window (the small mark visible at the centre of Photo 1) to confirm whether it is a chip, fixing or surface stain.
